Docket No. 217 – Development and Management Plan Inspection

Northeast Utilities Service Company Certificate of Environmental Compatibility and Public Need for the construction of a 345-kV electric transmission line and reconstruction of an existing 115-kV electric transmission line between Connecticut Light and Power Company's Plumtree Substation in Bethel, through the towns of Redding, Weston, and Wilton, and to the Norwalk Substation in Norwalk, Connecticut.

Date: July 26, 2005

Location: 345kV XLPE Component

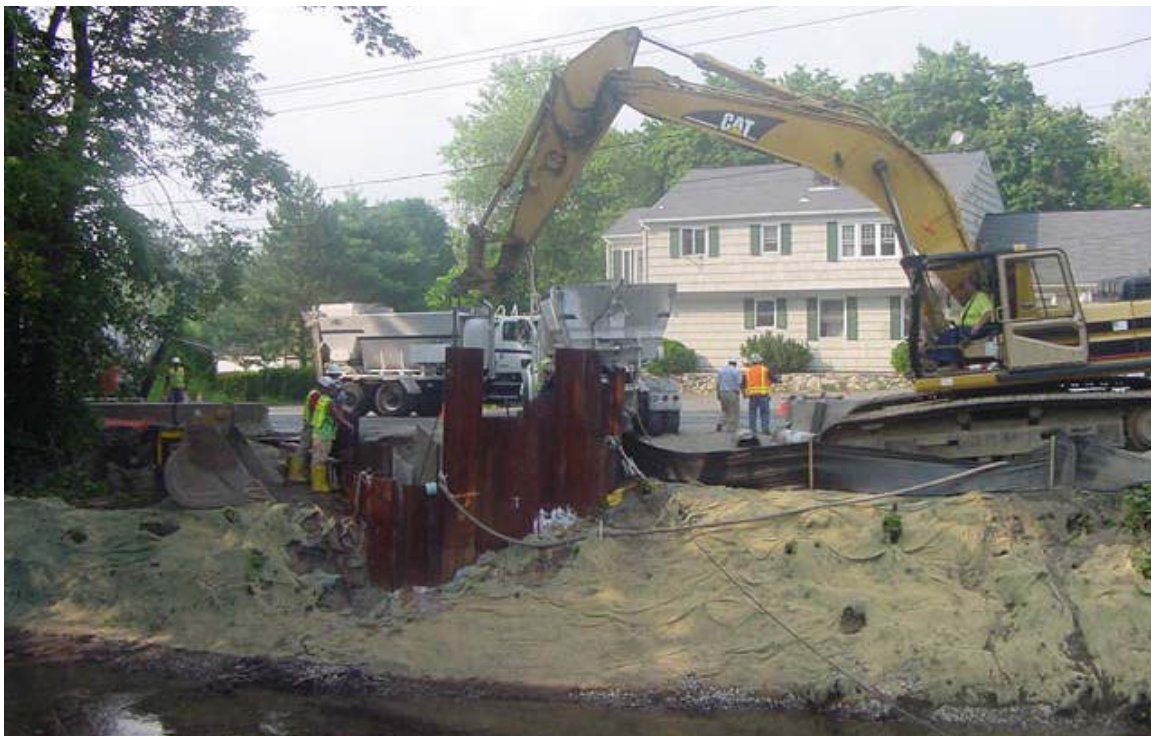
345kV XLPE: Photo shows the work continuing at the receiving pit of the Jack and Bore to complete the system. The stream bank was restored with erosion control blankets and silt fence was in good shape at the top of slope. 7/26/06

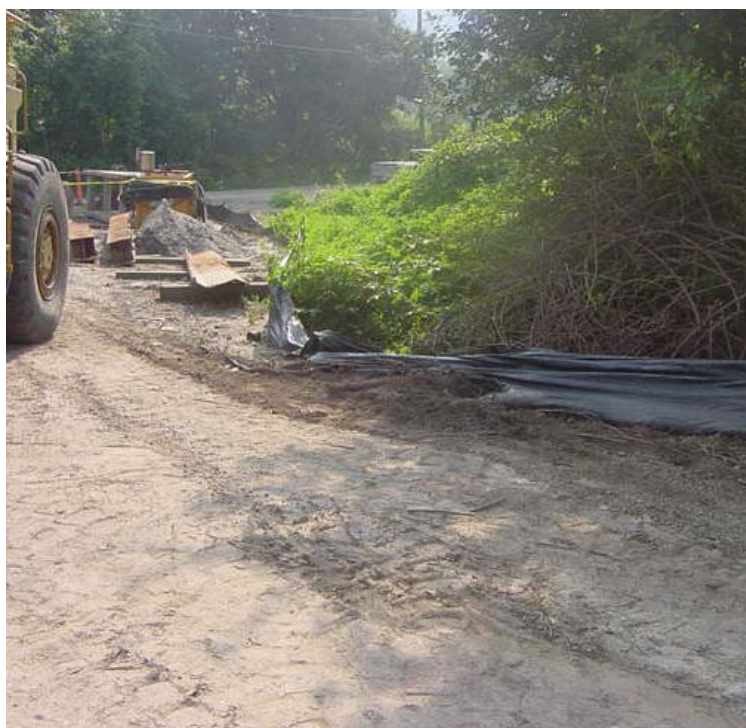
- Minor repairs are needed to the silt fence along the ball park access 7/26/06	- Repair as necessary. The adjacent area will be restored when work is complete. 7/26/06	- Needs attention when feasible

Photo on the left shows the silt fence along the means of access to the stream. The fence should be maintained due to the adjacent, disturbed soil. This area will be restored when work is complete. Photo on the right shows the jacking pit. Stockpiles and work remain contained to the site. 7/26/06
